**FUNDAMENTAL MECHANISMS OF
TENSILE FRACTURE IN ALUMINUM SHEET
UNIDIRECTIONALLY REINFORCED
WITH BORON FILAMENT**

*by Harvey W. Herring
Langley Research Center
Hampton, Va. 23365*

1. Report No. NASA TR R-383		2. Government Accession No.		3. Recipient's Catalog No.	
4. Title and Subtitle FUNDAMENTAL MECHANISMS OF TENSILE FRACTURE IN ALUMINUM SHEET UNIDIRECTIONALLY REINFORCED WITH BORON FILAMENT				5. Report Date April 1972

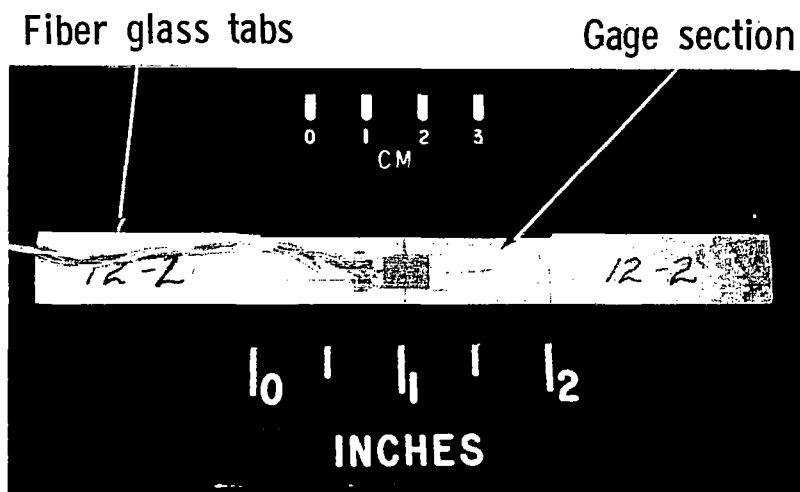
L-72-146

Figure 1.- Typical B-Al sheet tensile specimen prior to testing.

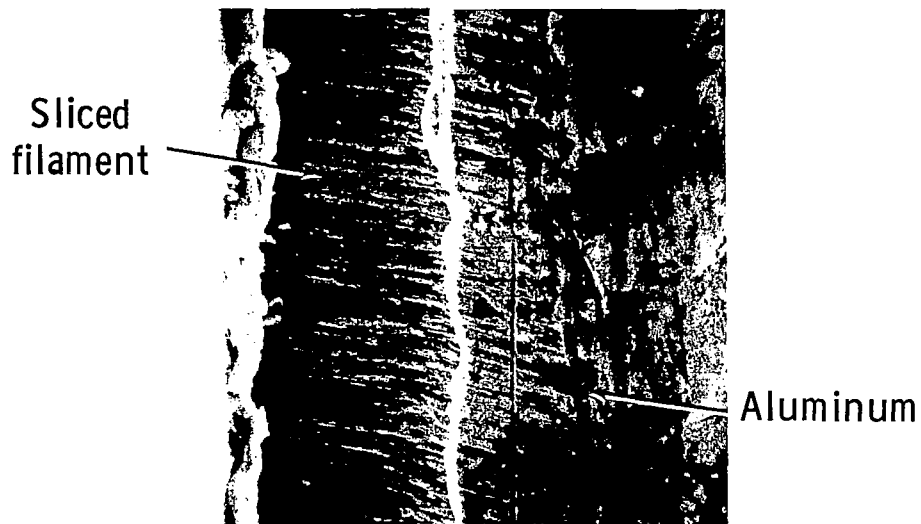
L-72-147

Figure 2.- Edge of bilayer B-Al composite tensile specimen cut by electrical-discharge method.

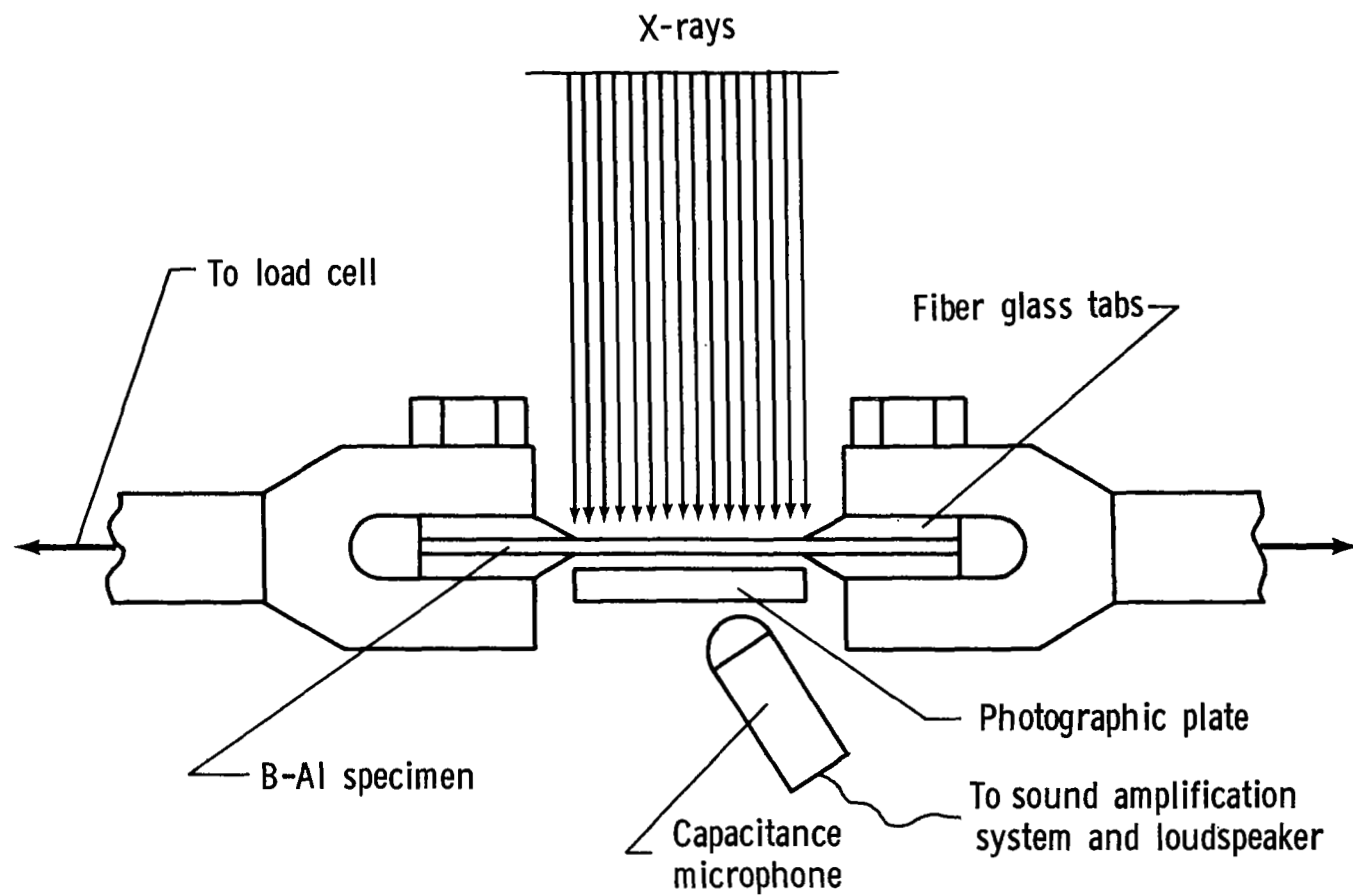
Figure 3.- Schematic drawing of apparatus used to study tensile fracture of B-Al composite sheet.

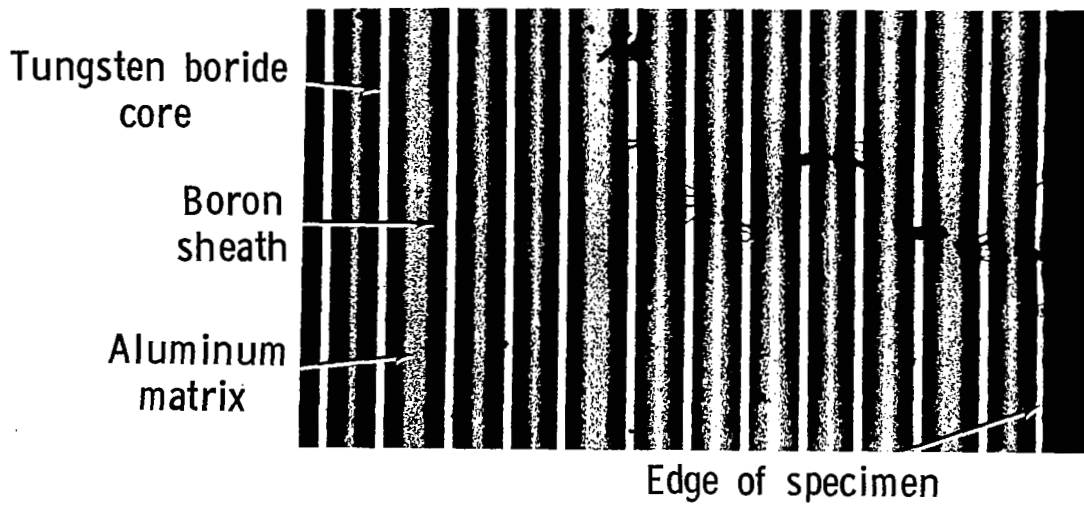
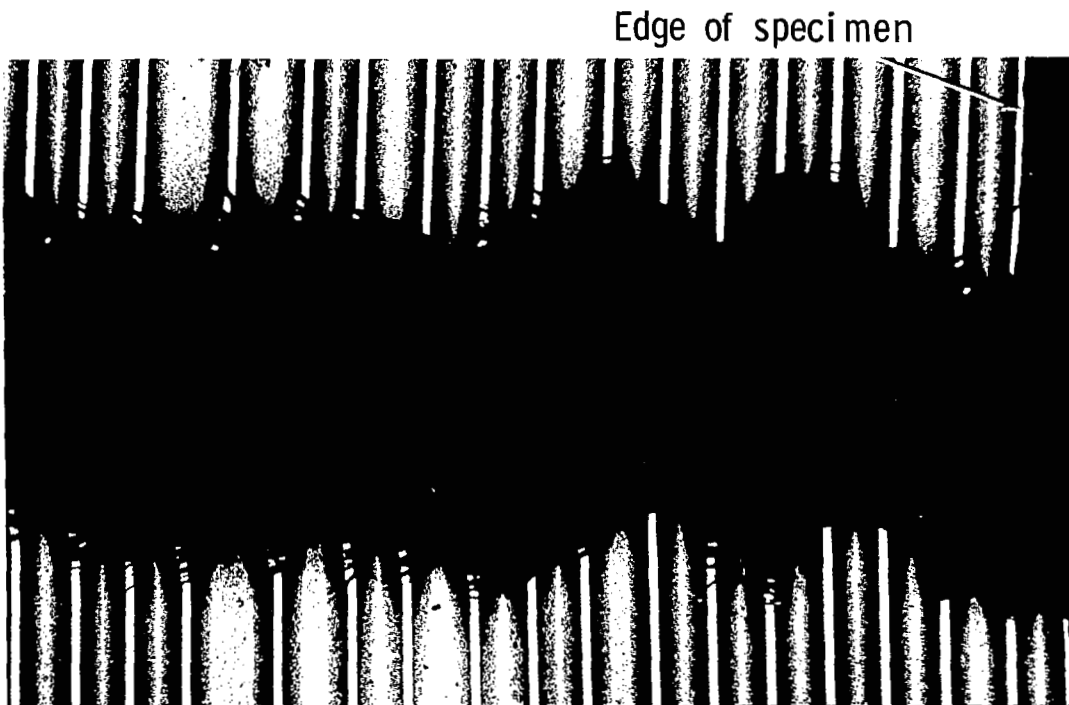
L-72-148

(a) Crack initiation near edge of specimen.

(b) Same region after complete fracture.

Figure 4.- Tensile fractoradiographs of monolayer B-Al composite.
Core diameter, 0.015 mm (0.0006 in.).

The radiograph of figure 4(a) reveals what appears to be the initial stage of tensile fracture in the form of several broken filaments extending inward from the edge of the specimen. The radiograph was taken through a tensile specimen which had been suddenly unloaded prior to total fracture as a result of failure of the testing machine. Apparently, noncumulative fracture had begun but was arrested by the accidental unloading. Two different filament fracture modes are observed. The third and fifth filaments from the edge of the specimen are broken cleanly, but the remaining filament breaks are characterized

by the presence of wedge-shaped fragments. The matrix between the broken filaments is still continuous and has remained visibly unaffected by the filament breaks.

In figure 4(b), the same region is shown after complete fracture of the specimen. All the additional filament breaks occurred by fragmentation, and the shape and distribution of the fragments bear a definite relationship to the direction of crack propagation. The wedge-shaped fragments are displaced in the direction of propagation, and the wedges are all oriented so that they appear as arrowheads pointing opposite to the direction of propagation.

Noncumulative fracture mechanism. - Based on the radiographs of figure 4, the following fracture mechanism is proposed: The third and fifth filaments from the edge of the specimen were weak and broke first. The elastic strain energy stored in each filament was abruptly released in the form of stress waves, which propagated transversely through the matrix. The stress waves impacted against adjacent filaments with sufficient force not only to shatter them, but also to displace the fragments within the matrix. Fragments from the fourth filament were not displaced because they were in a region where two waves of approximately equal energy content were oppositely directed; therefore, their displacement was neutralized. As each successive filament was broken, the energy content of the original stress wave was alternately depleted and replenished. The wave was completely damped in figure 4(a), but above some threshold value of average filament stress, the mechanism, which will hereinafter be referred to as noncumulative filament-break propagation, became self-sustaining, and catastrophic fracture resulted.

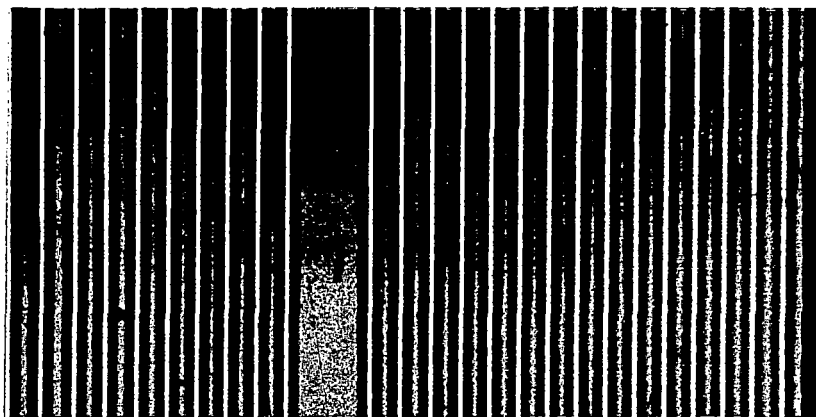
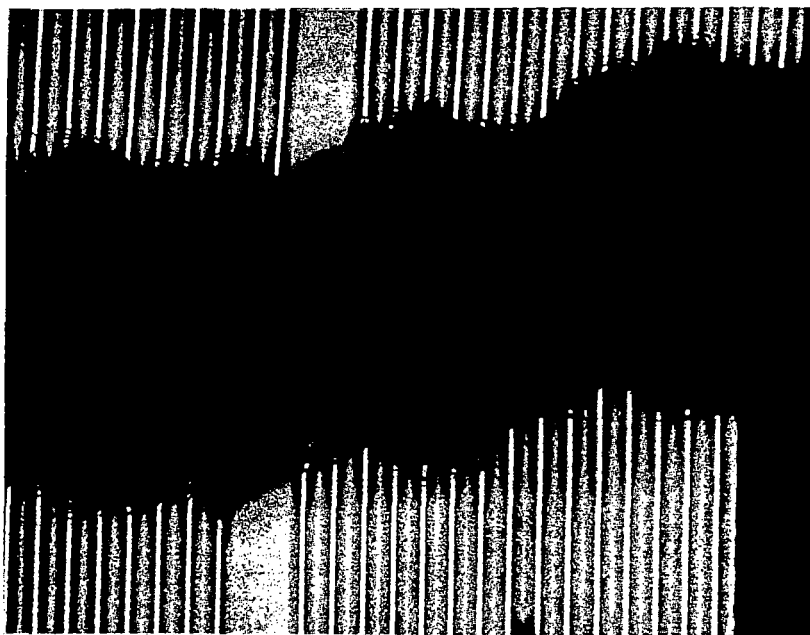
L-72-149

(a) Crack initiation near edge of specimen.

(b) Same region after complete fracture.

Figure 5.- Tensile fractoradiographs of monolayer B-Al composite with missing filaments. Core diameter, 0.015 mm (0.0006 in.).

A typical specimen with missing filaments is represented by the pair of radiographs presented as figure 5. Both radiographs were taken through the same region of a monolayer specimen which contained a gap created by the removal of two adjacent filaments. In figure 5(a), what may be the initial stage of noncumulative filament-break propagation is evident in the first three filaments from the specimen edge. Figure 5(b) shows the same region after complete specimen fracture. The stress wave was not damped as a result of the gap between filaments. The mechanism for noncumulative filament-break propagation described in the previous section continued across the gap to cause complete fracture of the specimen. Identical behavior was observed for specimens containing gaps produced by the removal of up to five filaments. Specimens with larger gaps were not tested; therefore, the ultimate gap width required to inhibit filament-break propagation was not determined.

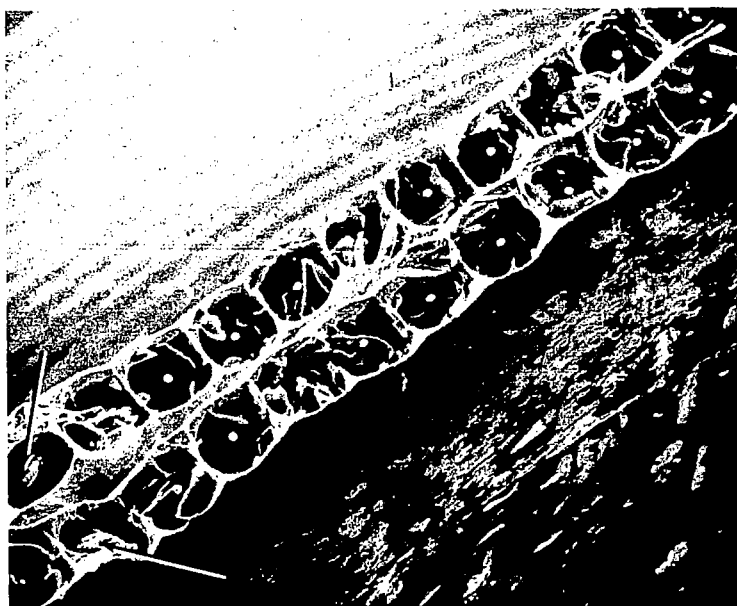
L-72-150

Figure 6.- General view of matching transverse fracture surfaces of monolayer B-Al composite showing filament fragmentation. Filament diameter, 0.14 mm (0.0056 in.).

Correlation with fracture surface features. - The photograph presented as figure 6 was taken of matching tensile fracture surfaces of a monolayer composite. The two halves of the specimen may be matched by mentally inserting the bulbous projection on the second filament up from the lower left corner (denoted by arrow) into its corresponding depression on the opposite surface. Two important features are observed which serve to corroborate the mechanism for noncumulative filament-break propagation discussed previously. One is the presence of wedge-shaped fragments associated with each broken filament. The second is related to fracture modes exhibited by the matrix.

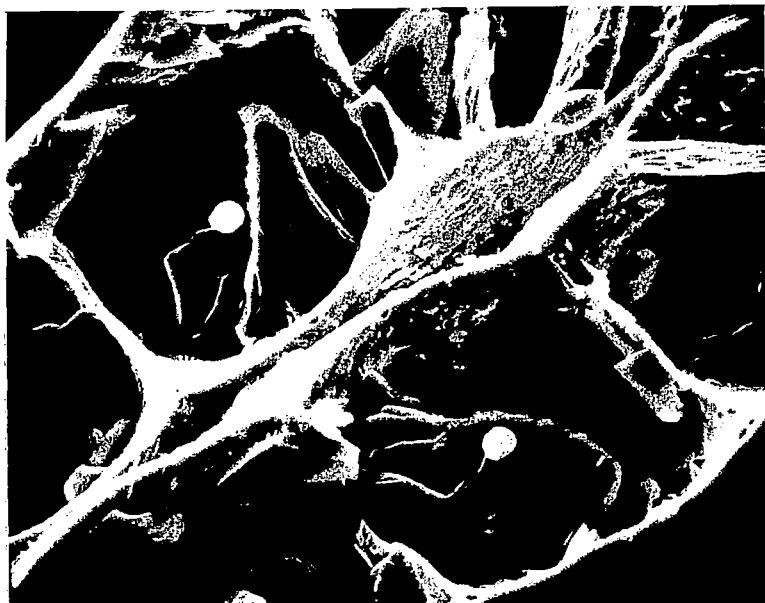
L-72-151

Figure 7.- Matching transverse fracture surfaces of monolayer B-Al composite showing details of matrix fracture. Filament diameter, 0.14 mm (0.0056 in.).

Details of the matrix fracture are more visible in the magnified view of figure 7. Each broken filament lies at the bottom of an aluminum crater whose outer walls have the appearance of the shear lip in a conventional cup-cone fracture. Also, a scalloped effect is observed along the boundaries of the overall specimen fracture surface as a result of restraint imposed by the filaments on necking of the matrix. At the junctions of crater walls, the presence of gross pores resulting from microvoid coalescence indicates the fracture mode there to be ductile rupture.

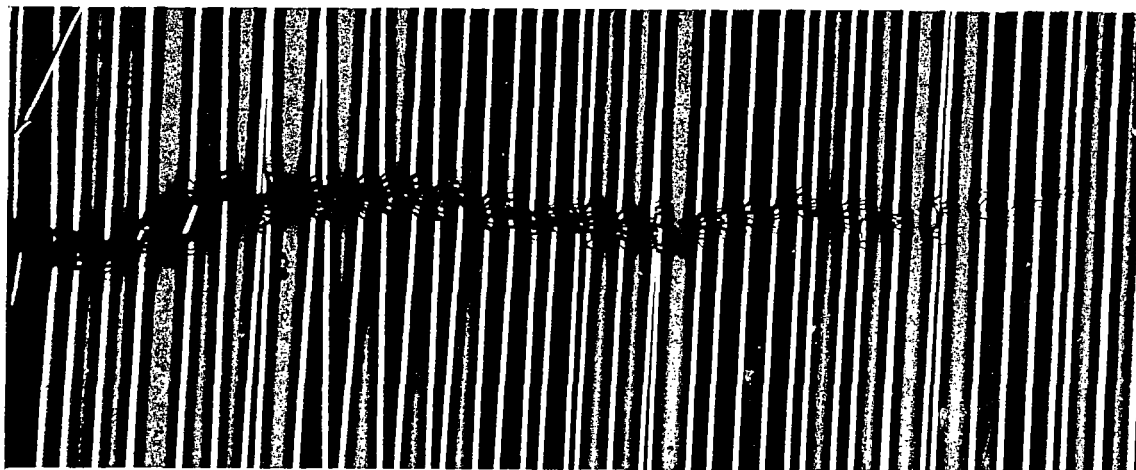
L-72-152

Figure 8.- Fractoradiograph showing arrested crack in bilayer
B-Al composite. Core diameter, 0.015 mm (0.0006 in.).

Initiation. - As a general rule, crack initiation occurred at a specimen edge. The radiograph presented as figure 8 shows an arrested crack extending inward from the edge of a specimen containing two layers of filament. The apparent irregularity in filament spacing is the result of looking through superimposed filament layers. The actual irregularity was not severe, as will be seen in subsequent fracture-surface observations. All the features of noncumulative filament-break propagation were present, including the displaced wedge-shaped fragments and broken filaments in advance of matrix fracture. Necking of the matrix between broken filaments could be seen in the region near the tip of the crack. Once a crack was initiated, three distinct fracture modifications were observed: transverse fracture, axial fracture, and canted fracture. Each modification was either related to or a result of noncumulative filament-break propagation. The three modifications are discussed in the following sections.

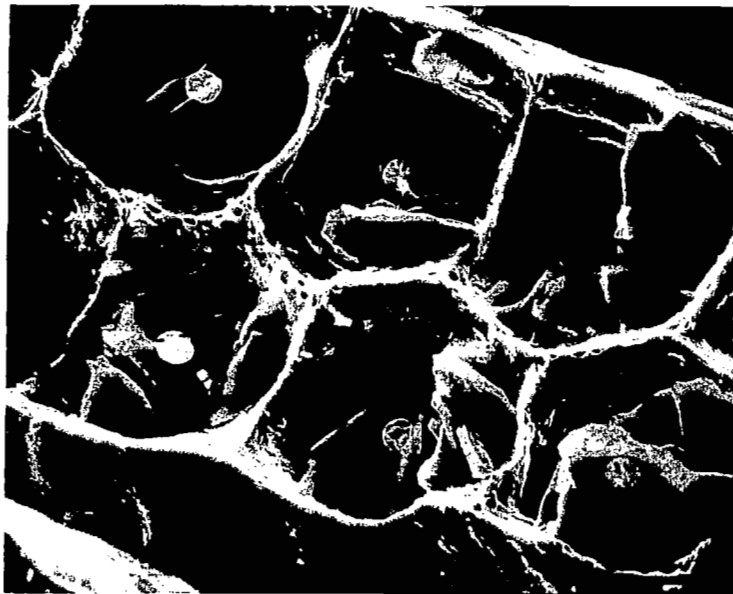
L-72-153

Figure 9.- General view of transverse fracture surface of bilayer B-Al composite showing filament fragmentation. Filament diameter, 0.099 mm (0.0039 in.).

Transverse fracture. - Transverse fracture occurred when filaments from all layers in the composite failed by noncumulative filament-break propagation in a single plane perpendicular to the axis of loading. A typical transverse fracture surface of bilayer composite is shown in figure 9. The fracture morphology was very similar to that already observed for monolayer composite (figs. 6 and 7), except that in the bilayer material the crater walls intersected in a hexagonal rather than in a rectangular pattern. The magnified view of figure 10 shows details of the interior crater wall, including the shear lip and porosity at lines and points of ultimate separation in the matrix.

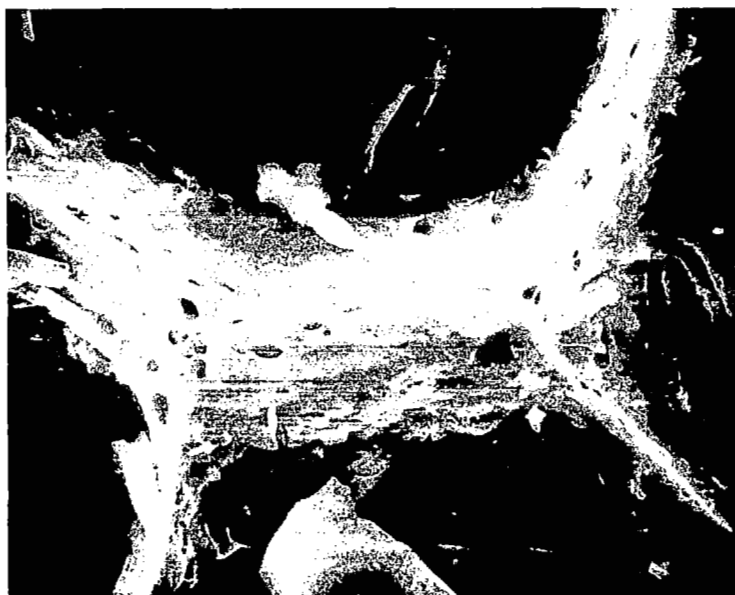
L-72-154

Figure 10.- Transverse fracture surface of bilayer B-Al composite showing details of matrix fracture. Filament diameter, 0.099 mm (0.0039 in.).

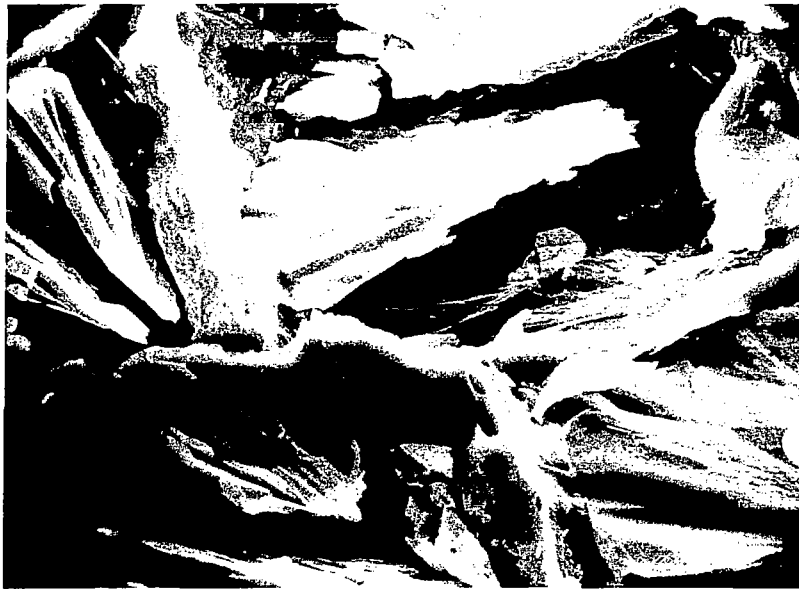
L-72-155

Figure 11.- Typical boron filament fragments in a transverse noncumulative fracture surface. Filament diameter, 0.099 mm (0.0039 in.).

The shapes and arrangements of fragments associated with the fracture of filaments were typified by those shown in figures 11, 12, and 13. No attempt was made to interpret the markings on fragment surfaces. Figure 11 shows the general appearance of fragments in a single transverse fracture surface. Figure 12 does likewise but also serves to focus attention on the regions of separation between constituents of well-bonded composite. The matrix-matrix bond (denoted by arrow) has ruptured only within a very small volume in spite of the violence of a fracture process which left filament debris scattered widely. A measure of the tenacity of the filament-matrix bond was indicated by the incipient formation of dimples around the periphery of the large fragment at the bottom of the photograph. Figure 13 shows matching fragments from a single filament in two photographs taken of mating transverse fracture surfaces. Matching core segments are indicated by arrows for one fragment pair.

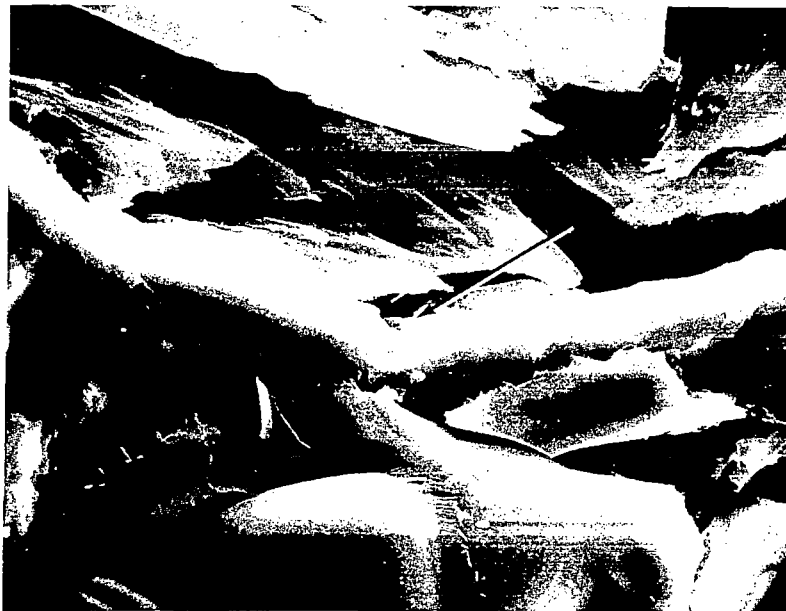
L-72-156

Figure 12.- Filament-matrix and matrix-matrix separation in transverse noncumulative fracture surface. Filament diameter, 0.099 mm (0.0039 in.).

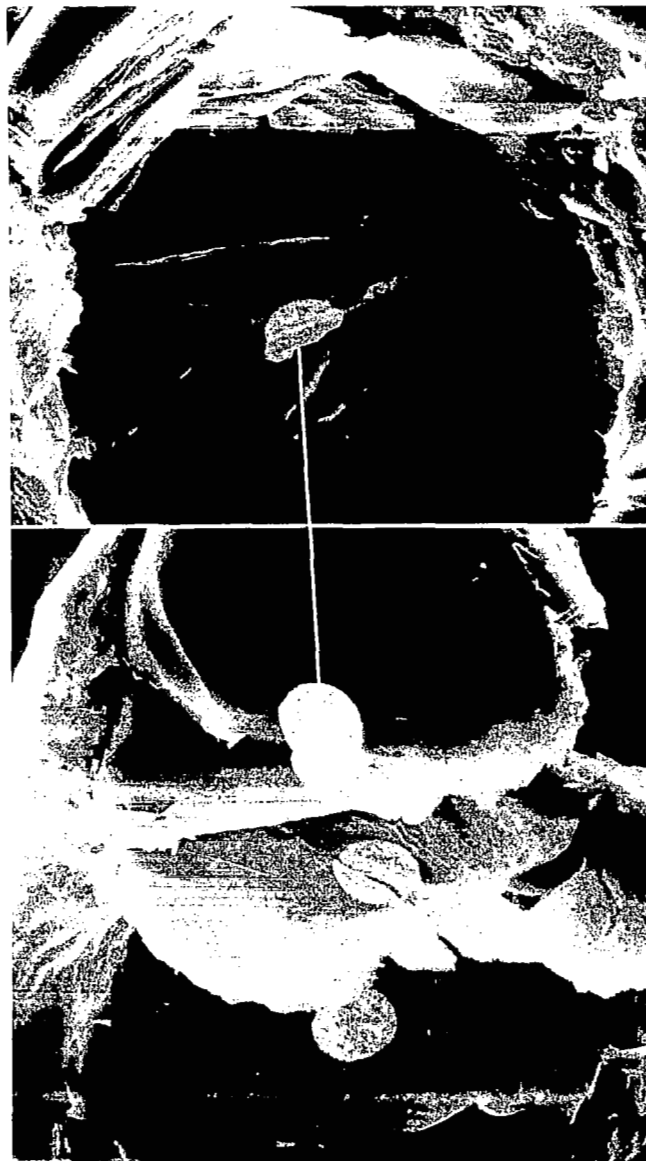
L-72-157

Figure 13.- Matching boron filament fragments from
mating transverse noncumulative fracture surfaces.
Filament diameter, 0.099 mm (0.0039 in.).

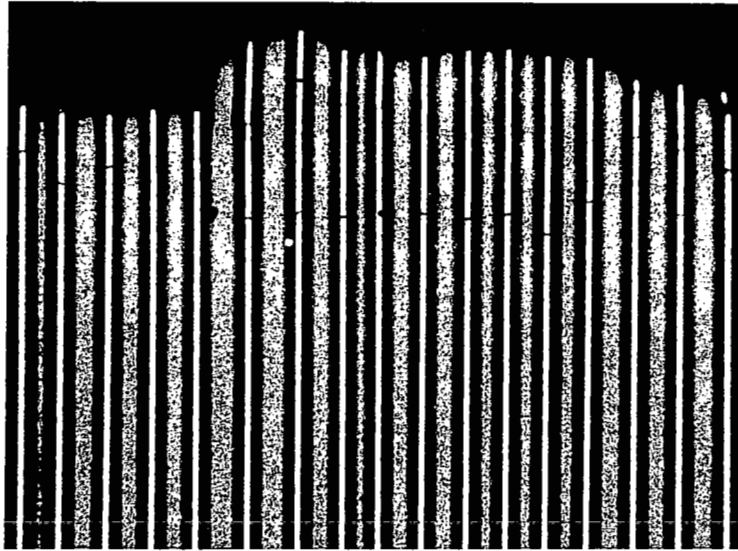
L-72-158

Figure 14.- Fractoradiograph showing rare transverse noncumulative fracture without wedge-shaped fragments. Core diameter, 0.015 mm (0.0006 in.).

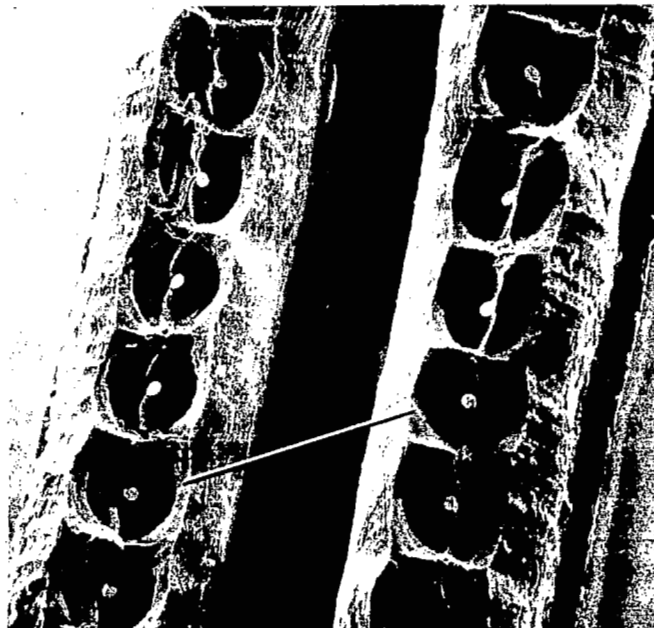
L-72-159

Figure 15.- Matching transverse fracture surfaces of monolayer B-Al composite showing filaments split instead of fragmented. Filament diameter, 0.099 mm (0.0039 in.).

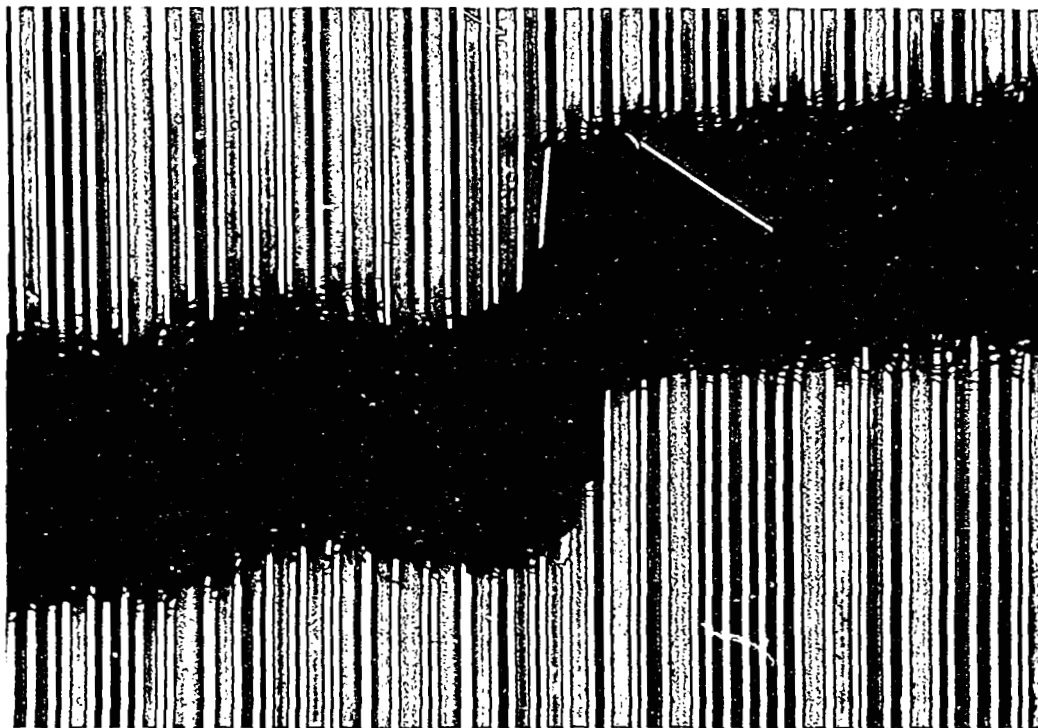
L-72-160
Figure 16.- Fractoradiograph of bilayer B-Al composite exhibiting
axial fracture. Core diameter, 0.015 mm (0.0006 in.).

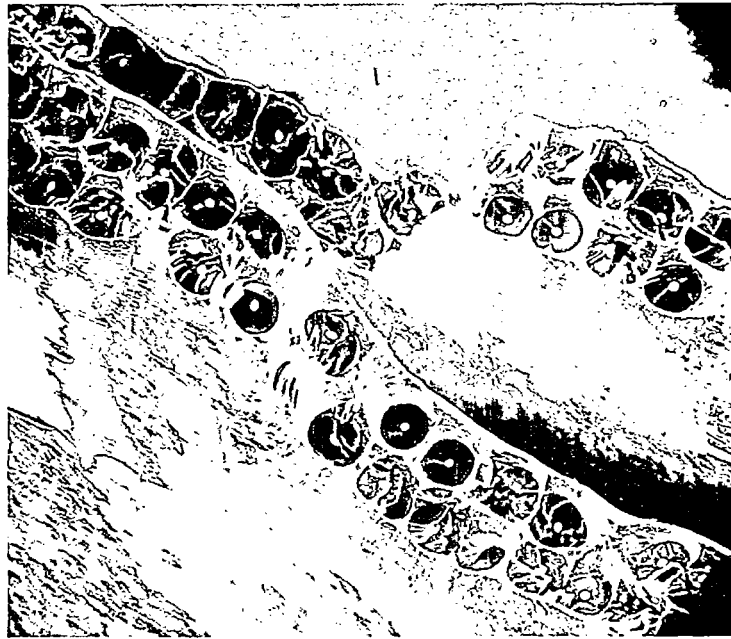
L-72-161

Figure 17.- General view of matching fracture surfaces of bilayer B-Al composite exhibiting axial fracture. Filament diameter, 0.099 mm (0.0039 in.).

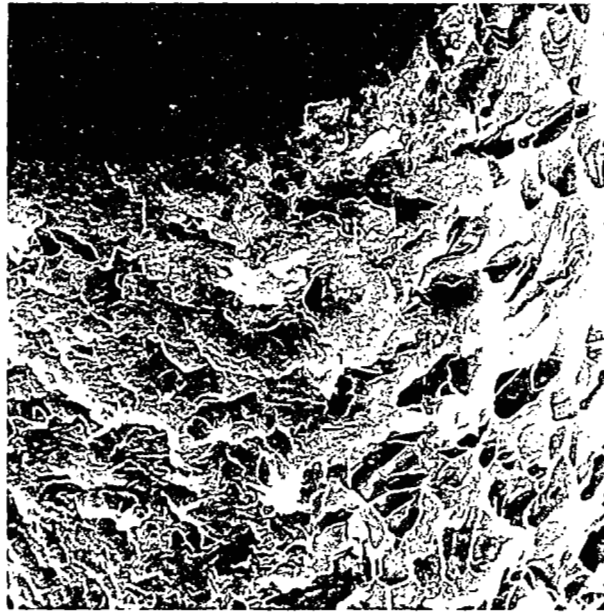
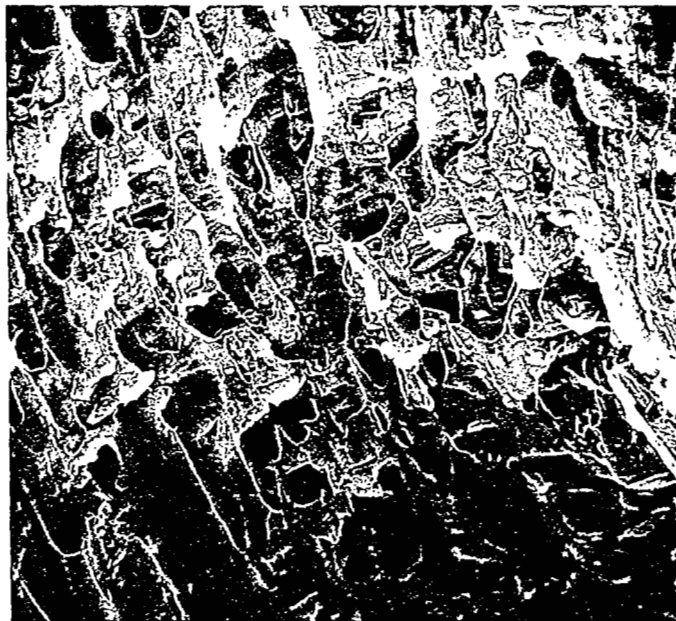
L-72-163

(a) Rupture on side of exposed filament in axial shear surface.

(b) Matching surface from which exposed filament was separated.

Figure 19.- Evidence of shear rupture. Filament diameter,
0.099 mm (0.0039 in.).

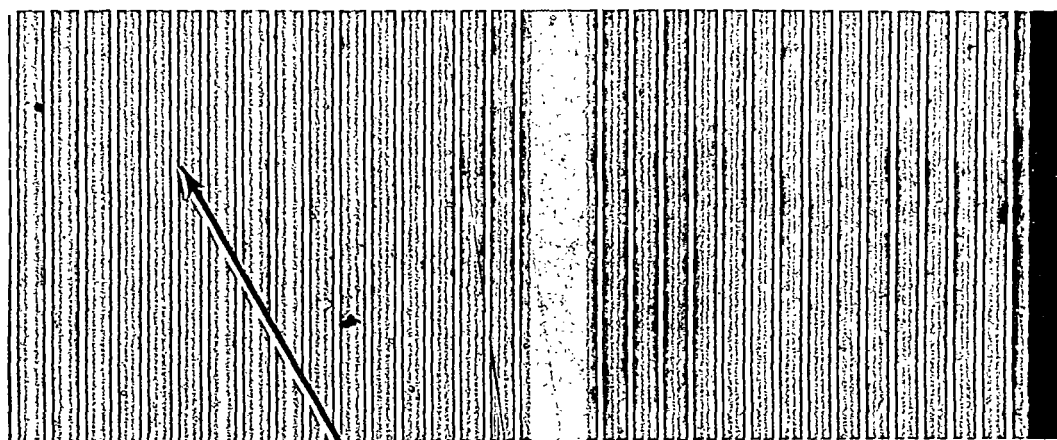
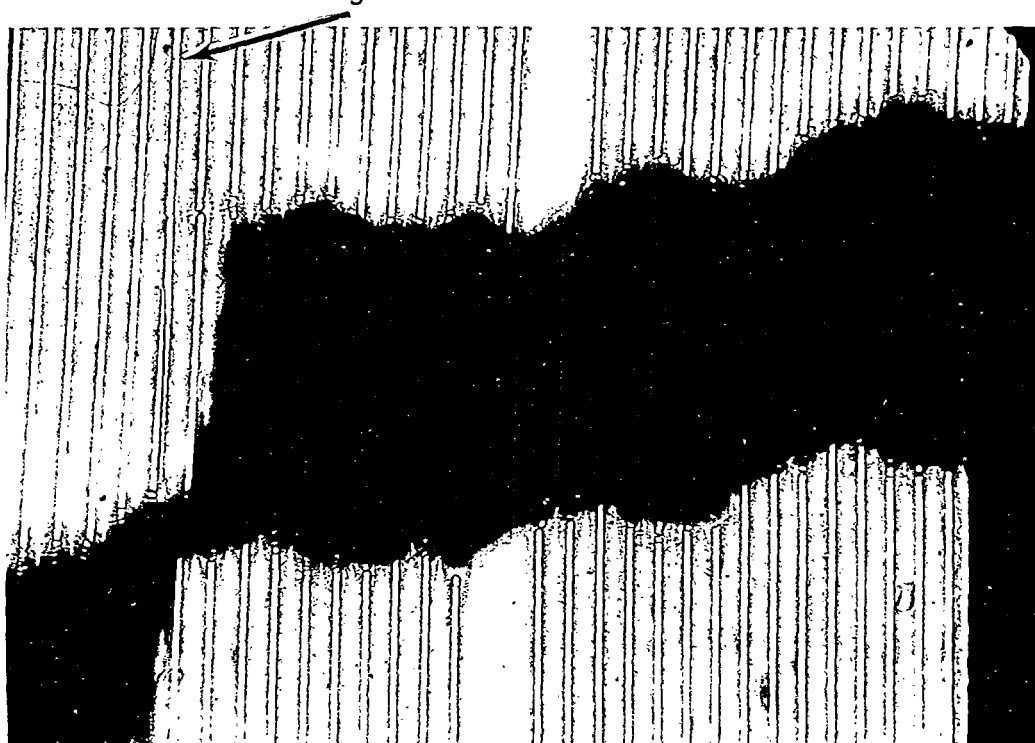
L-72-164

Figure 20.- Fractoradiographs of monolayer B-Al composite showing role of preexisting filament break in promoting development of axial fracture. Core diameter, 0.015 mm (0.0006 in.).

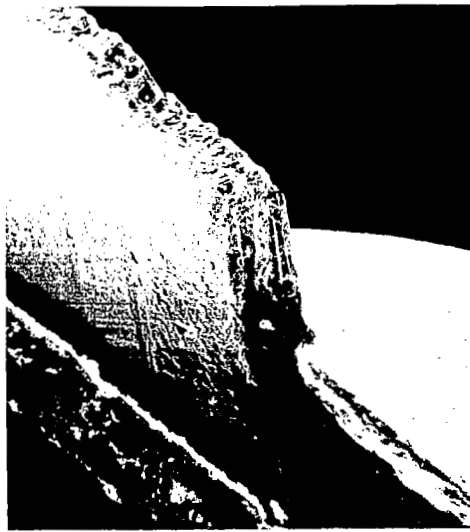
L-72-165

Figure 21.- General view of bilayer B-Al composite fracture surface with split filament in axial portion. Filament diameter, 0.099 mm (0.0039 in.).

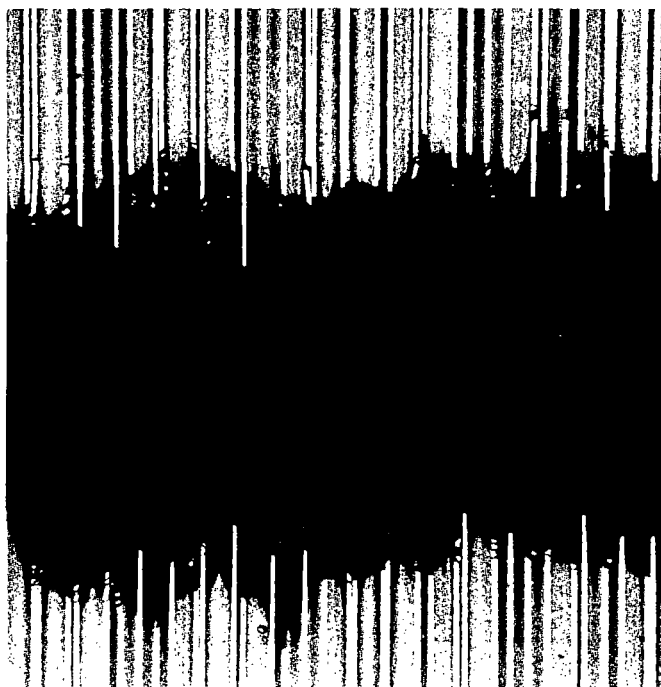
L-72-168

Figure 24.- Fractoradiograph of bilayer B-Al composite exhibiting canted fracture. Core diameter, 0.015 mm (0.0006 in.).

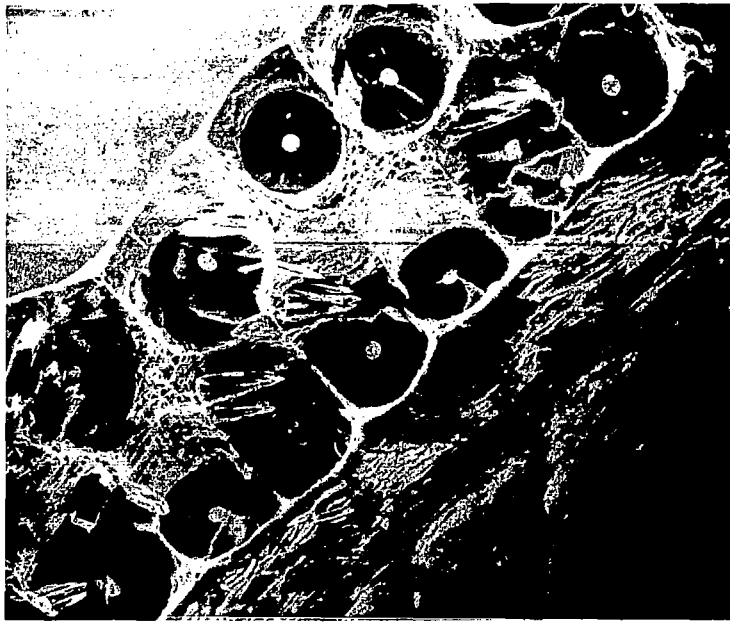
L-72-169

Figure 25.- Details of a canted fracture surface in
bilayer B-Al composite. Filament diameter,
0.099 mm (0.0039 in.).

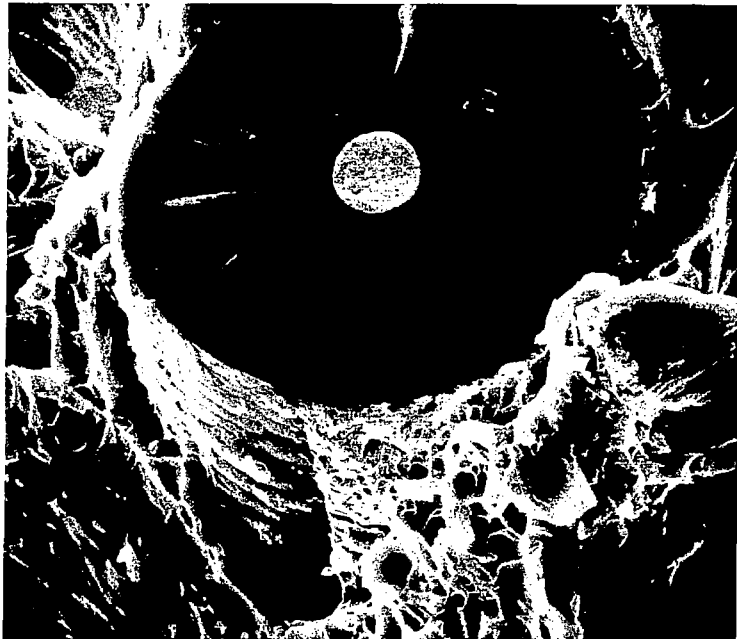
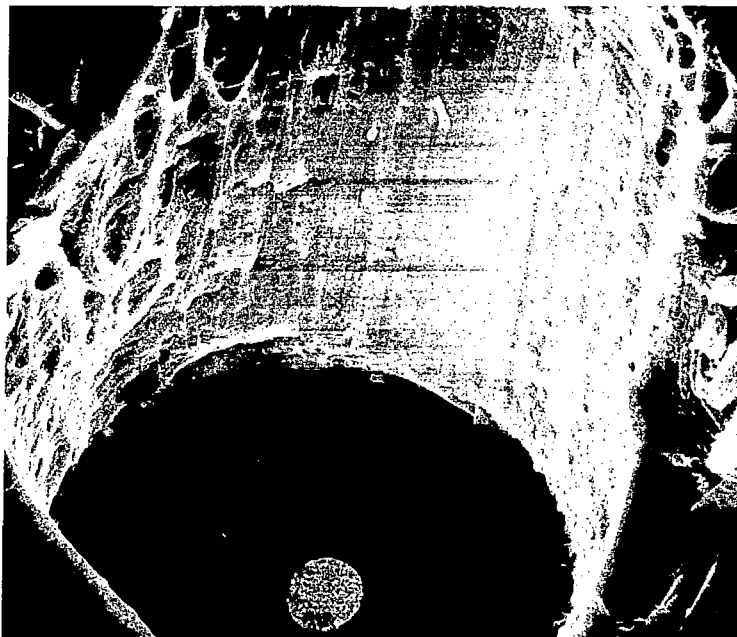
(a) Unbonded strip on side of exposed filament.

L-72-171
(b) Corresponding unbonded area in mating surface.

Figure 27.- Matching 0.099-mm-diameter (0.0039-in.) filament fracture surfaces in canted fracture region.

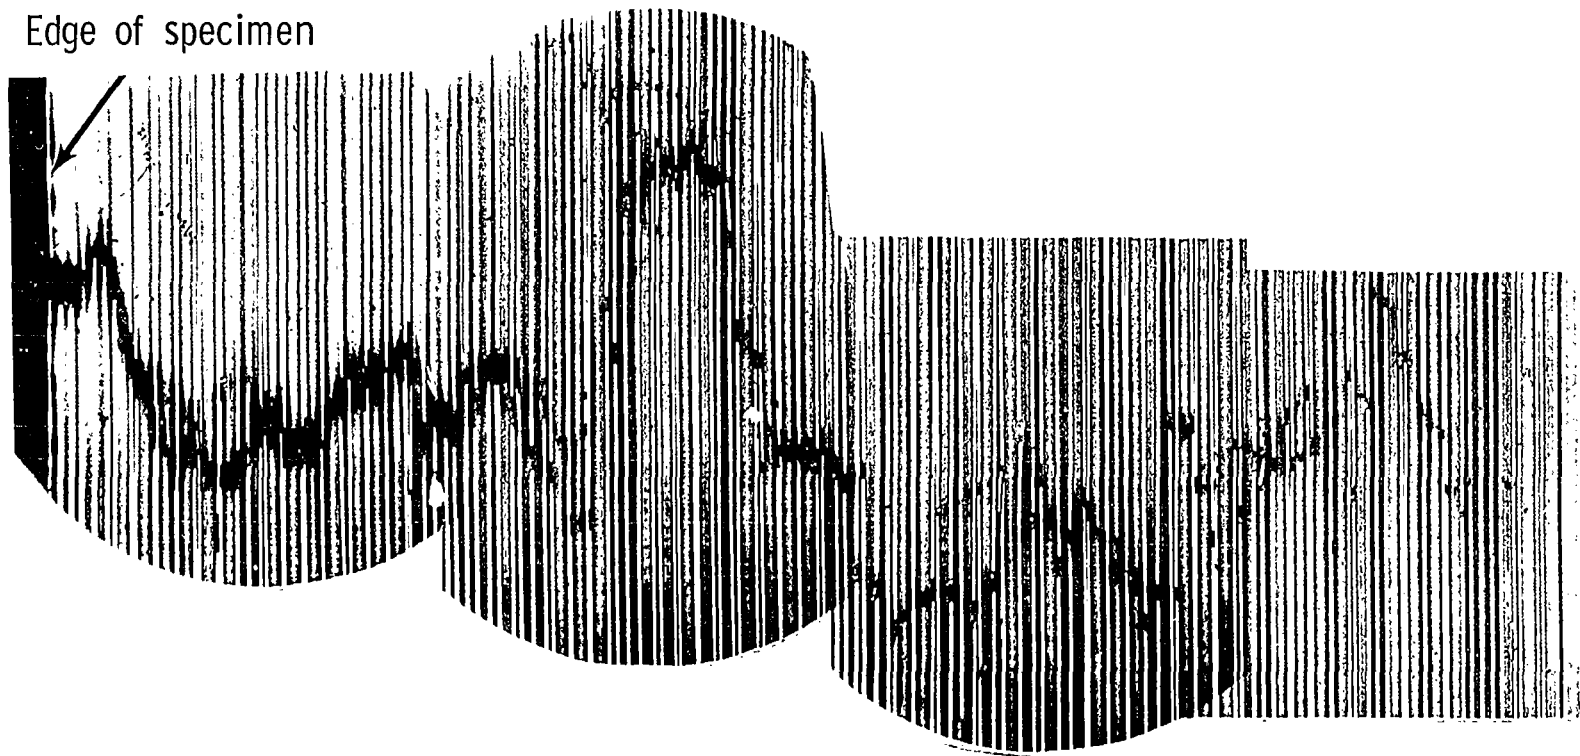
L-72-173
Figure 29.- Fracturadiograph showing arrested cumulative crack in bilayer B-Al composite.
Core diameter, 0.015 mm (0.0006 in.).

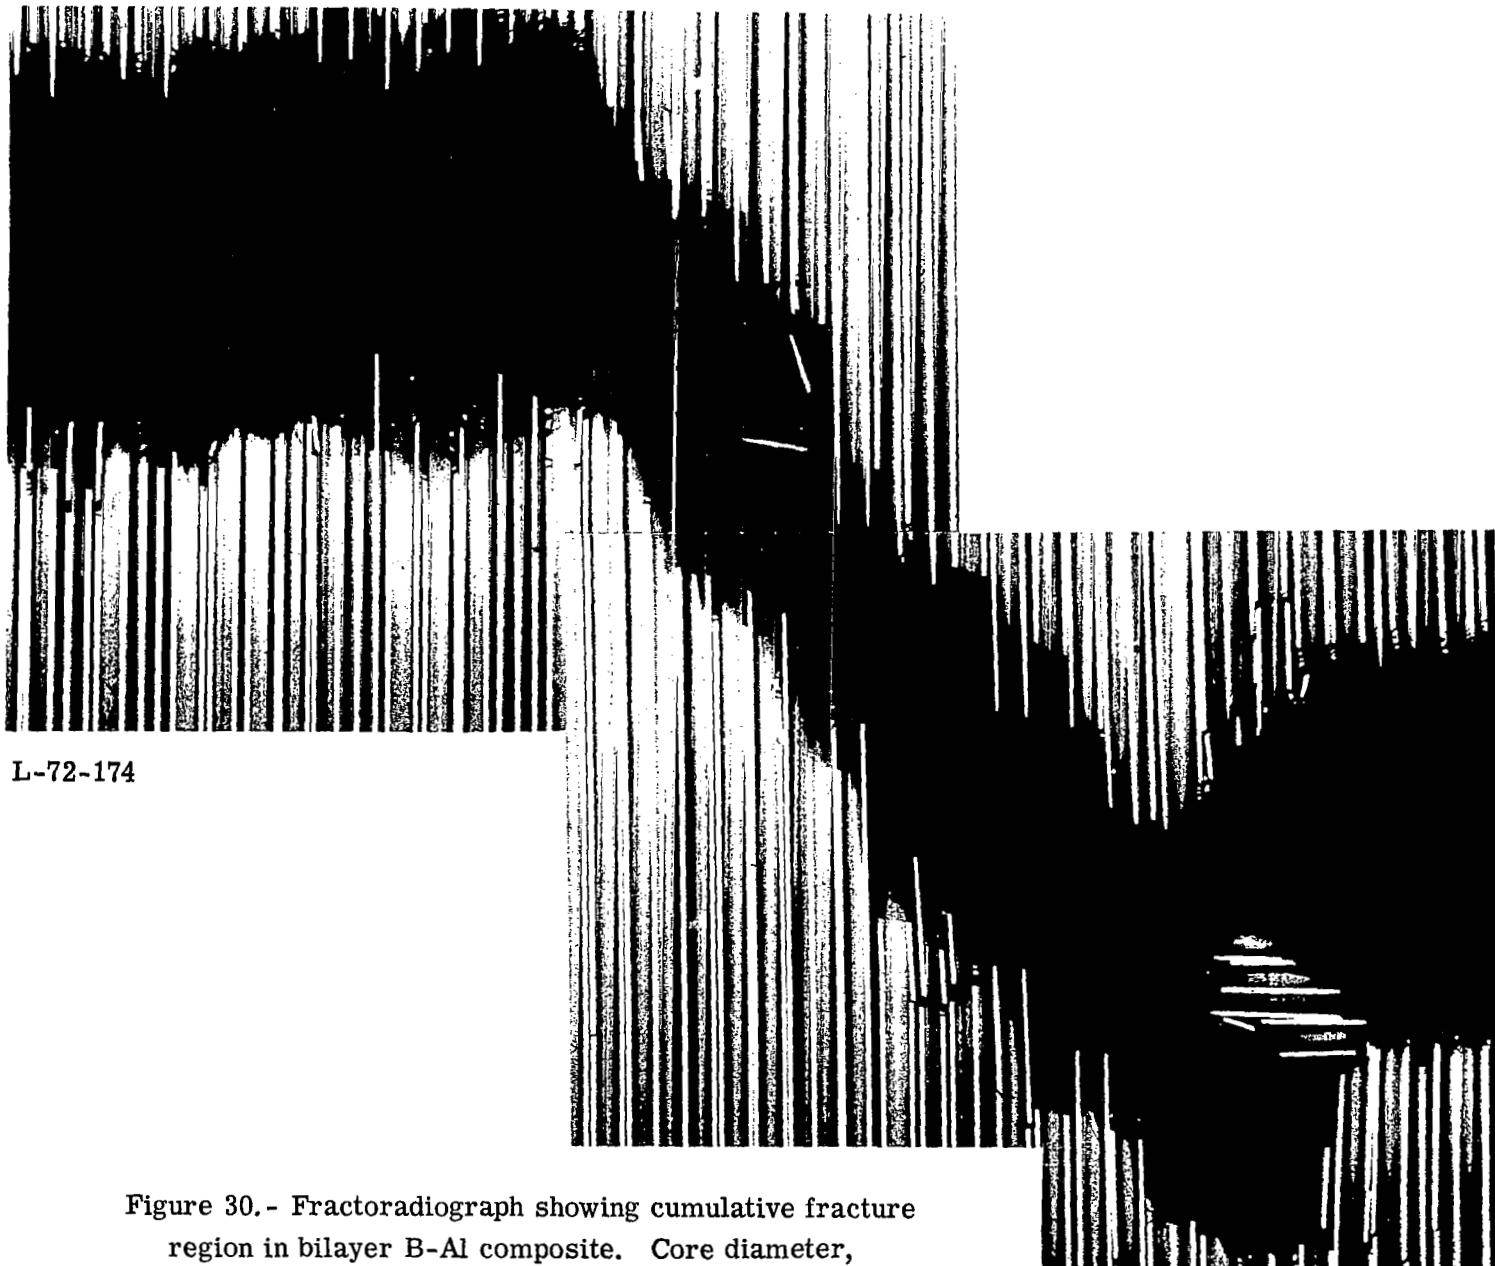
L-72-174

Figure 30.- Fractoradiograph showing cumulative fracture region in bilayer B-Al composite. Core diameter, 0.015 mm (0.0006 in.).

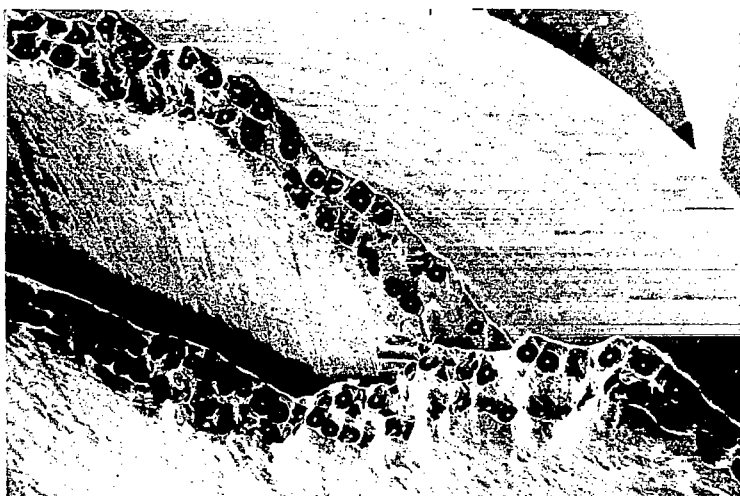
L-72-175

Figure 31.- General view of cumulative region in matching bilayer B-Al composite fracture surfaces. Filament diameter, 0.099 mm (0.0039 in.).

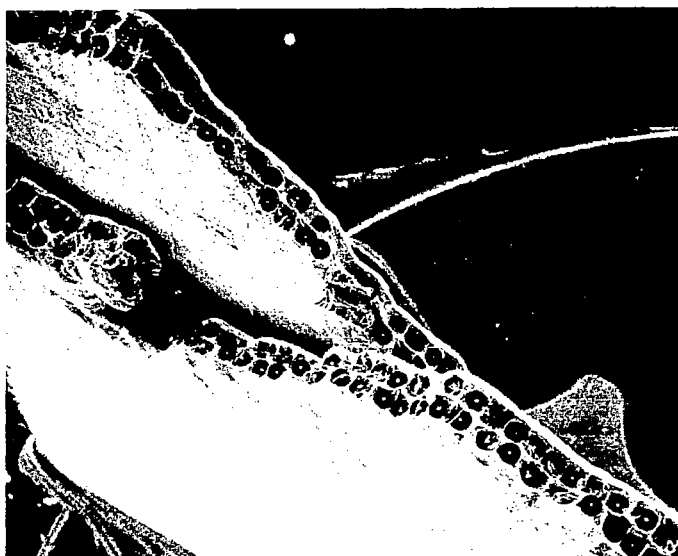
L-72-176

Figure 32.- Same surface as in figure 31, but rotated to show surface hidden in figure 31.

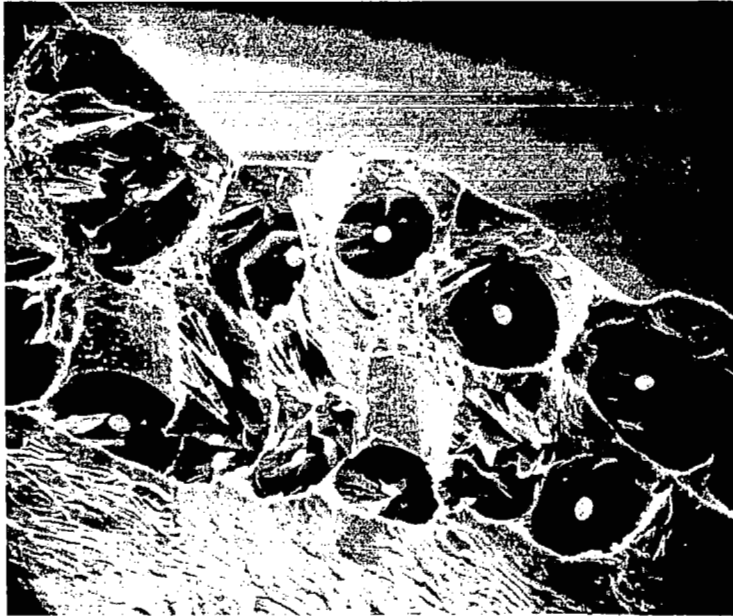
L-72-177

Figure 33.- Details of a canted fracture surface associated with partially cumulative fracture in bilayer B-Al composite. Filament diameter, 0.099 mm (0.0039 in.).

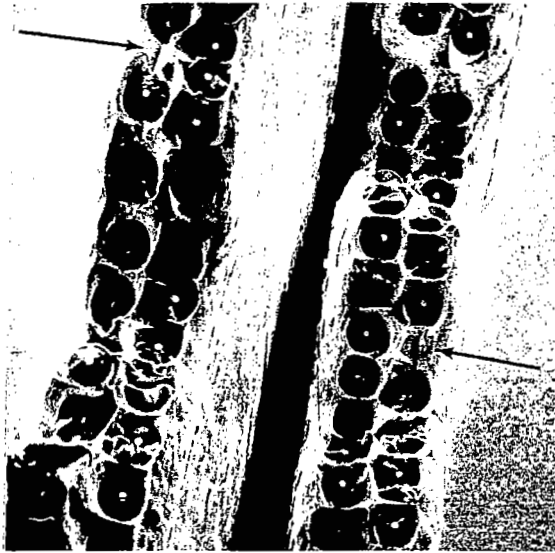
L-72-178

Figure 34.- General view of matching fracture surfaces in bilayer B-Al composite with weak internal bonding. Filament diameter, 0.089 mm (0.0035 in.).

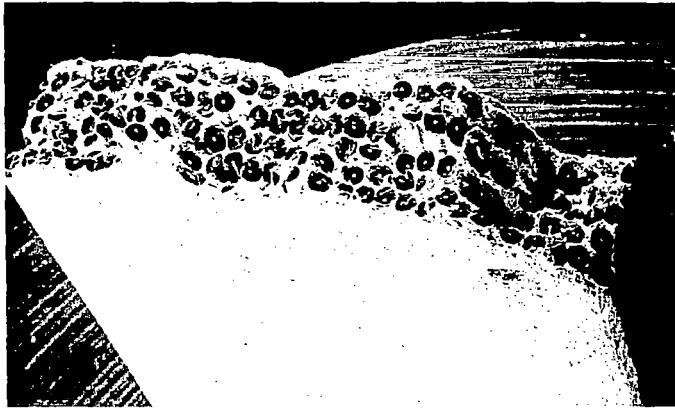
L-72-180

Figure 36.- General view of fracture surface commercially fabricated five-layer composite.
Filament diameter, 0.10 mm (0.0041 in.).
